Ultrasound imaging artifacts: How to recognize them and how to avoid them

Mary M. Quien MD

| Muhamed Saric MD, PhD

Leon H. Charney Division of
Cardiology, New York University Langone
Health, New York, New York

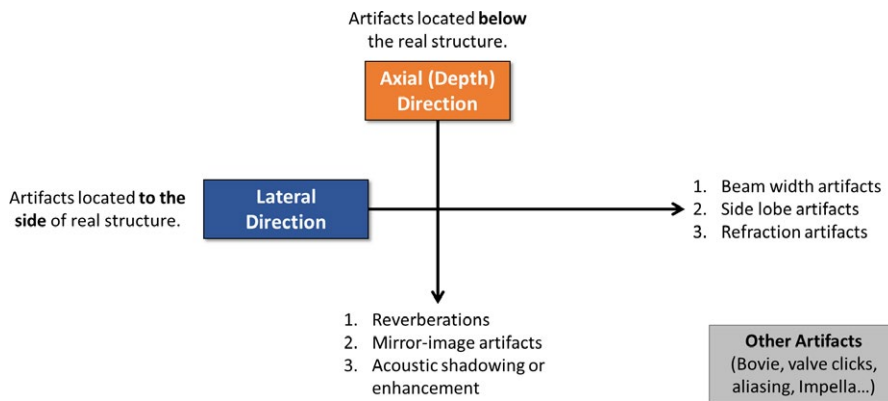
FIGURE 1 Cartoon depicting categories of assumption violation artifacts based on location relative to the true image

In general, there are two groups of echocardiographic imaging artifacts—those related to violation of assumptions built into ultrasound imaging equipment and those related to interference by external equipment and devices. Artifacts due to assumption violations occur in a predictable fashion and may result in displacement of image elements, masking or enhancement of image elements, or duplication of image elements. Assumption violation artifacts may occur below the true images (artifacts in axial direction) or to the side of the true image (artifacts in lateral direction) as summarized in Figure 1. Artifacts due to external equipment and devices include those related to cauterization, prosthetic valves, ventricular assist devices, and so forth.

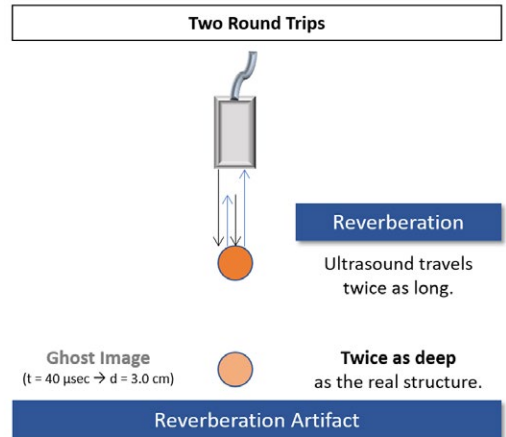
What happens when the time measured represents more than a single round trip?

FIGURE 2 Cartoon illustrating the ultrasound assumption and how violation of this assumption results in the reverberation artifact

The reverberation artifact violates the assumption that an echo returns to the transducer after one reflection. In theory, when the ultrasound wave is emitted from the transducer, it interacts with surface of the structure, and the reflected wave is transmitted directly back to the transducer, making a single round trip (Figure 2). In reality, the reflected ultrasound wave can encounter a closer reflector on its way back to the transducer. One portion of the wave travels back to the transducer as expected, while the other portion is instead reflected back to the original structure.

The portion that was caught by the second reflector essentially makes a second round trip by traveling back to the original structure before eventually making it back to the transducer. Because the ultrasound system assumes that the wave only makes one round trip, the transducer interprets this longer travel time as a reflection coming from a structure that is further away than the original structure. Thus, the transducer produces an artificial image below the original structure at twice the distance between the transducer and the structure (Figure 3). Parallel motion at this distance can usually be seen and is a good indicator of this artifact. The second reflector is often the transducer itself, but can also be other common reflectors, such as the aorta, calcified structures, and implanted devices.⁴

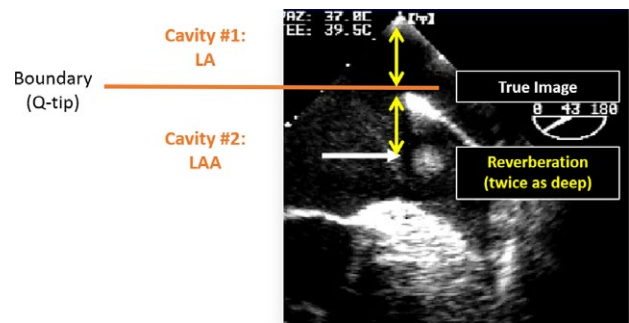
FIGURE 3 (Corresponds to Movie S1). Reverberation artifact in the left atrial appendage (white arrow) that could be mistaken for a thrombus. LA = left atrium; LAA = left atrial appendage

for complementary use or as the initial diagnostic procedure if the patient is stable enough.^{16,17} To decrease false positive diagnosis of LAAT, one should utilize multiplane TEE with a systematic approach of imaging from multiple windows and at multiple angles.

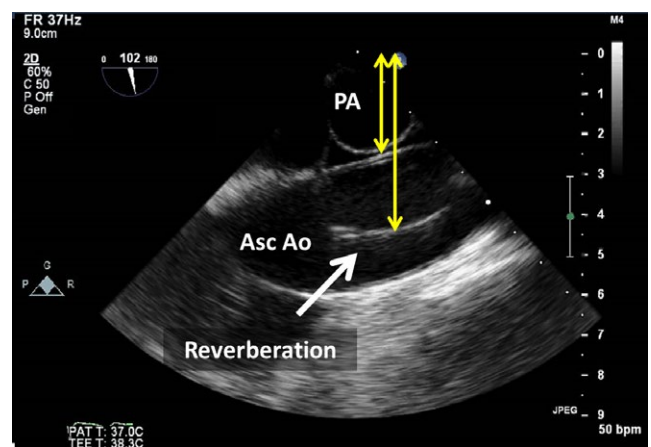
FIGURE 4 (Corresponds to Movie S2). Reverberation artifact (white arrow) in ascending aorta at approximately twice the distance from the transducer (yellow arrows) that could be mistaken for aortic dissection. Asc Ao = ascending aorta; PA = pulmonary artery

Several studies have shown that the sensitivity of transesophageal echocardiography (TEE) for the diagnosis of aortic dissection is high (ranging from 97% to 100%), but that the specificity can be as low as 68%.⁵⁻⁷ This low specificity is mainly attributed to false positive diagnoses of Stanford type A dissections due to misinterpretation of simple reverberation artifacts (Figure 4).

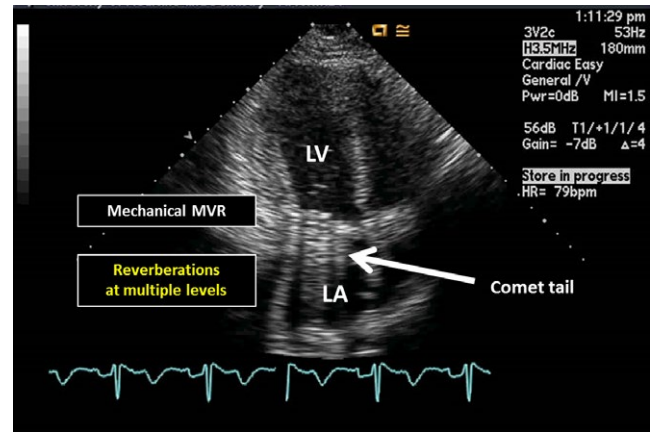
FIGURE 5 (Corresponds to Movie S3). Comet tail artifact (white arrow) originating from a mechanical St. Jude mitral prosthesis. LA = left atrium; LV = left ventricle

The complex reverberation artifact, also known as the comet tail artifact, is produced in the same fashion as the simple reverberation artifact. In this case, though, there are usually two or more reflectors that are very close together, and the process involves multiple round trips. With each subsequent round trip, the artificial image produced is moved further below the original structure, and the signal intensity becomes progressively weaker. The characteristic appearance of the artifact is shown in Figures 5 and 6.

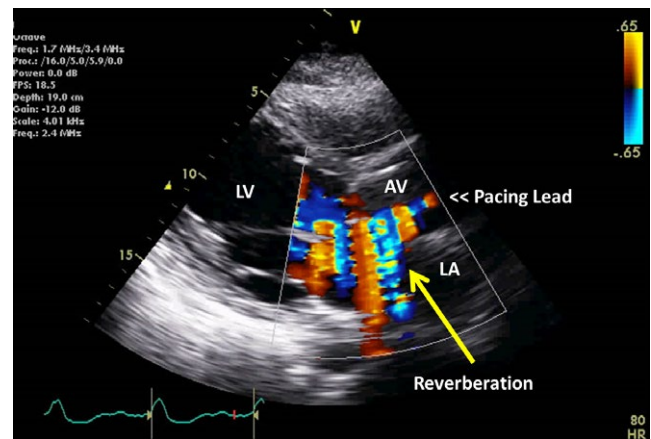
FIGURE 6 (Corresponds to Movie S4). Reverberation artifact (yellow arrow) due to a pacing wire in the right heart. AV = aortic valve; LA = left atrium; LV = left ventricle

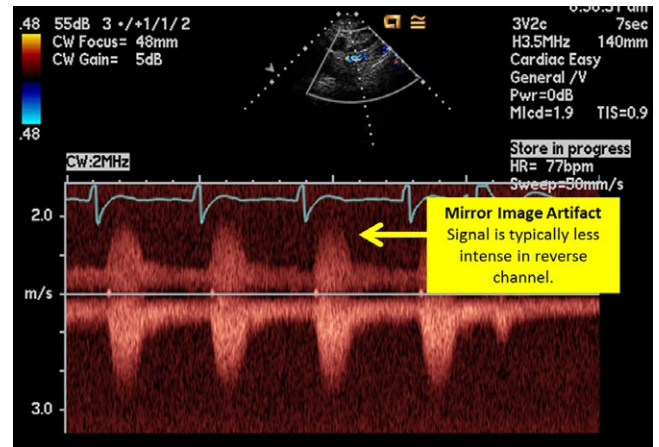
FIGURE 8 Mirror image artifact shown in Doppler of the subclavian artery of a patient with a functioning left-arm dialysis shunt

When mirror artifacts lead to misdiagnosis, they are often found leading to confusion about the flow in two adjacent vessels in spectral and color Doppler (Figure 8). For example, in patients with mitral valve prostheses, mirroring of the left ventricular outflow tract flow (LVOT) can result in misdiagnosis of MR. One group observed that in patients with tilting disk mitral valve prostheses, color Doppler images from transthoracic echocardiography (TTE) apical views, which suggested significant MR, differed greatly from images from TEE or angiography, which showed only trace physiologic MR.²⁶ Another study examined a similar cohort and found that 12% had a discrepancy between echocardiographic and operative findings of the degree of MR. In 3.4%, no abnormalities were found at the time of operation even though they had a preoperative echocardiographic diagnosis of prosthetic dysfunction.²⁷ These studies thus show that a misdiagnosis of MR can be problematic, leading to further evaluation, more imaging, and even unwarranted cardiac catheterization or surgery.

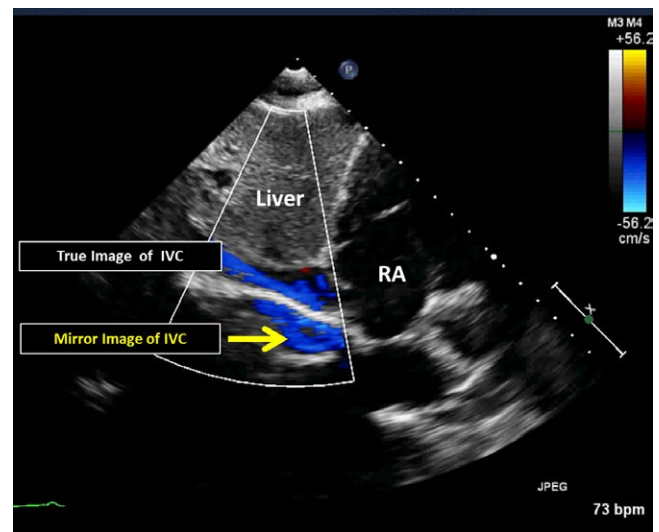
FIGURE 9 (Corresponds to Movie S6). Mirror artifact producing an inverted inferior vena cava (yellow arrow). RA = right atrium

Mirror artifacts can also complicate the evaluation of major vessels. For example, the artifact can produce a complete vessel duplication (Figure 9), which can confound sonographers' interpretations of the subclavian region.²⁸ These artifacts have also been commonly found in the carotid arteries and have led to problems in diagnosing stenosis and plaques.²⁹ One of the most important consequences of misinterpretation of this artifact is a false diagnosis of dissection,

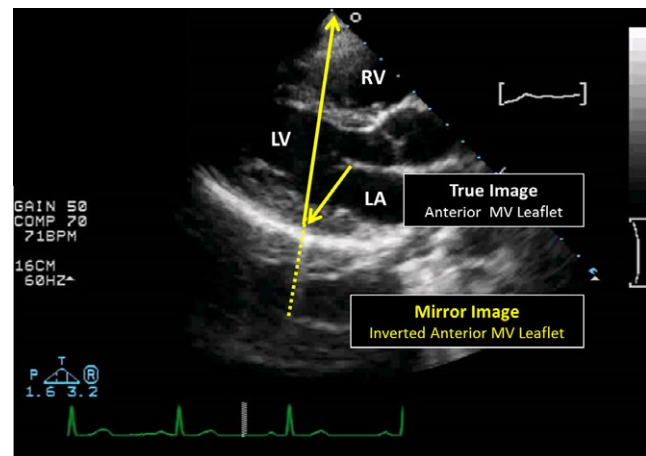
FIGURE 7 (Corresponds to Movie S5). Trajectory of the ultrasound wave as it travels back to the transducer (solid line), bouncing off a reflective object and producing a mirror artifact of the anterior mitral valve leaflet (dotted line). LA = left atrium; LV = left ventricle; RV = right ventricle

The mirror image artifact violates the assumptions that the ultrasound wave moves in a linear path and that the echo returns to the transducer after a single reflection. In this scenario, the ultrasound wave from the transducer is initially reflected from the desired object at an angle (angle of reflection = angle of incidence) and then encounters a highly reflective structure that is between the transducer and the initial object (Figure 7). The wave then travels back to the initial object before traversing to the transducer. The transducer does not recognize that the wave took an indirect path on its way back. Instead, it assumes that the longer travel time indicates that the intervening structure must be along a straight path below the initial object, and thus maps a false image of the intervening structure as such. The false image acts as a mirrored object: inverted and moving in the opposite direction as the true intervening structure. These artifacts are usually easy to identify as one can usually see both the original structure and its mirror image in the same frame.

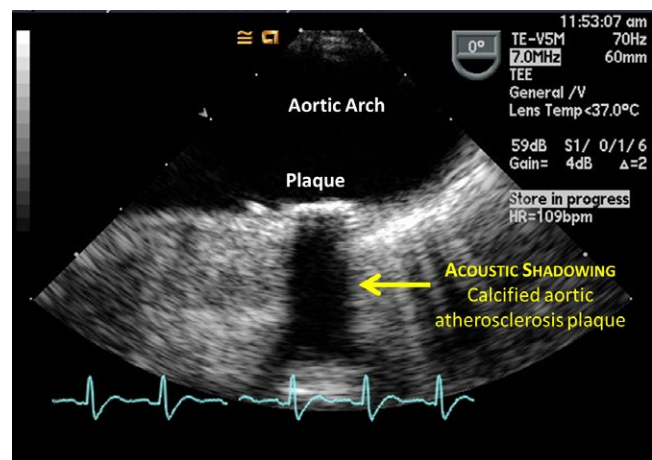
FIGURE 10 (Corresponds to Movie S7). Calcified aortic atherosclerosis plaque causing acoustic shadowing artifact (yellow arrow)

Acoustic shadowing (Figures 10 and 11) can be found with any calcium-containing structure, prosthetic valves, and even silicone breast implants. This artifact has been known to be particularly problematic in evaluating paravalvular leaks in patients with prosthetic valves due to shadowing from the prosthesis material.³³ The anterior feature of the aortic ring is especially difficult to visualize because of shadowing from the posterior valve ring.³⁴

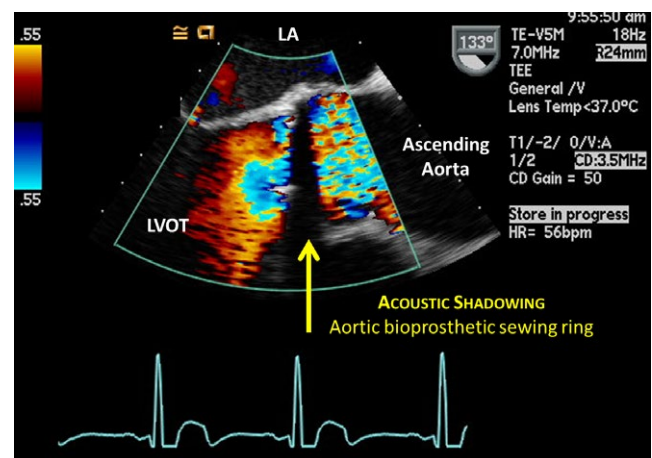
FIGURE 11 (Corresponds to Movie S8). Shadowing artifact (yellow arrow) caused by aortic bioprosthetic sewing ring. LA = left atrium; LVOT = left ventricular outflow tract

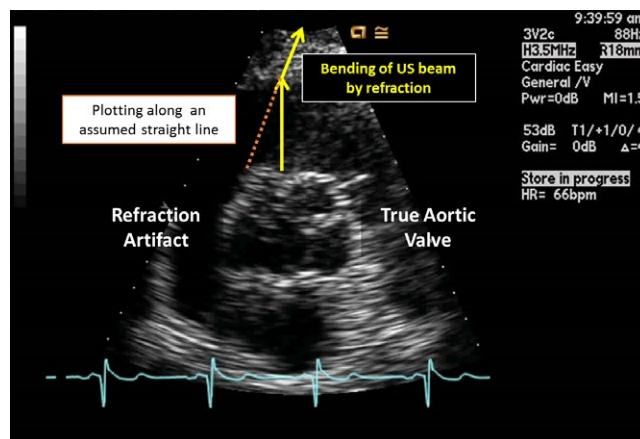
FIGURE 13 (Corresponds to Movie S10). Demonstration of the altered path of the wave (dotted line), leading to refraction artifact showing duplication of the aortic valve

The refraction artifact violates the assumptions that the path of the ultrasound wave is straight and that the speed of the ultrasound wave is uniform. In this scenario, instead of the ultrasound wave traveling directly to the cardiac object and back to the transducer, the wave encounters a structure that acts as a wave refractor. This structure essentially behaves as a lens.⁴² As the wave goes through the structure, the path of the wave is bent at the interface, and the speed of the wave is changed depending on material of the structure. This results in duplication (often partial) of the cardiac object that appears as a sort of ghost image to the side of the true image (Figure 13). The produced image is similar to that of the mirror image artifact, but it appears next to instead of underneath the true image. Common inducers of refraction artifacts are costal cartilage, fascial structures and fat, and pleural and pericardial surfaces.^{43,44}

These artifacts are most often seen on the short-axis view of the aortic valve and left ventricle, but they are described only a few times in literature. When reported, they are commonly found depicting duplications of the mitral, aortic, or pulmonary valve.^{44,45}

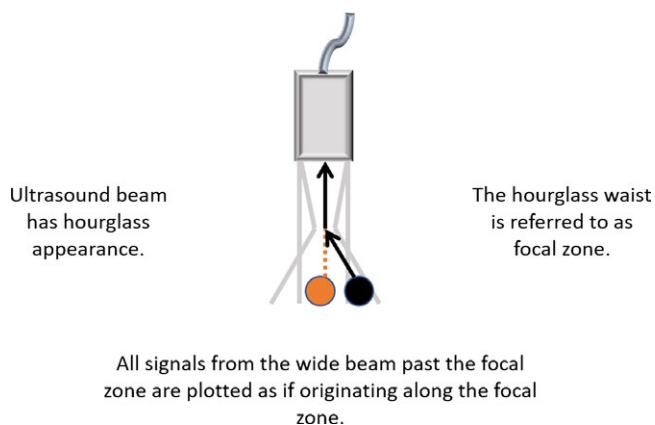
FIGURE 14 Cartoon demonstrating the mechanism behind beam width artifact

The beam width artifact violates that assumption that echoes are generated only from reflectors located within the main ultrasound beam. To comprehend this artifact better, one must understand the actual shape of the ultrasound beam. As the beam exits the transducer, it maintains approximately the same width as the transducer. It then narrows to a certain point (called the focal zone) and then widens again as it continues to move further from the transducer to a width often beyond that of the transducer.⁴⁶ This gives the ultrasound beam a sort of hourglass appearance (Figure 14). If there is a highly reflective object in the widened base of the beam, the ultrasound system will think that the echo from this object originates from the focal zone. Thus, ghost images of these highly reflective objects can become visible along the same plane of the real image.

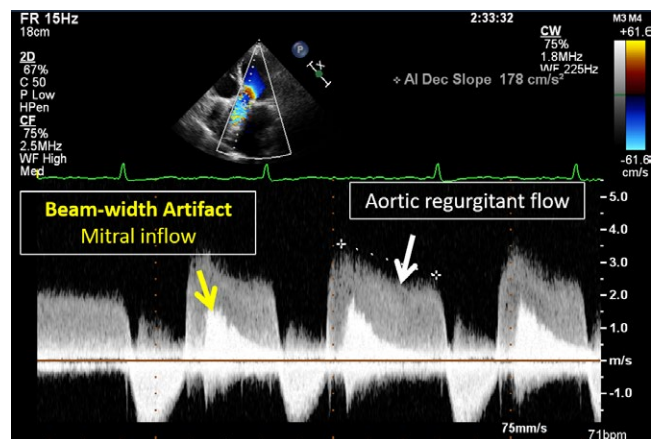
FIGURE 15 Beam width artifact of mitral inflow (yellow arrow) projected onto the aortic regurgitant flow (white arrow)

example is portrayed in Figure 15. The mitral flow is projected onto the aortic regurgitant flow, creating the illusion of a significant degree of aortic regurgitation. Confusion about valvular flow can lead to incorrect diagnoses and potentially unjustified surgery depending on the indication.

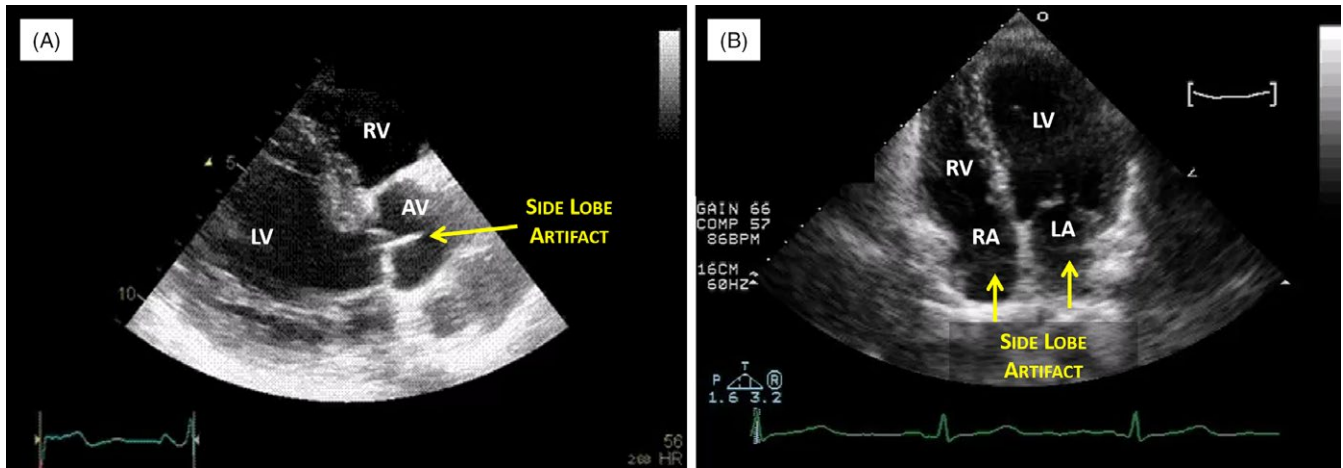
FIGURE 16 (Panel A corresponds to Movie S11, and Panel B corresponds to Movie S12). Two examples of how side-lobe artifacts (yellow arrows) can lead to intra-cavitary clutter and be mistaken for thrombus or vegetations. AV = aortic valve; LA = left atrium; LV = left ventricle; RA = right atrium; RV = right ventricle

Like beam width artifacts, side-lobe artifacts (Figure 16) have been shown to greatly confuse the interpretation of left ventricular thrombosis and vegetations as they can mimic these masses, especially when using fundamental frequency imaging.⁵² They are also the leading cause of intra-cavitary clutter. Despite its high

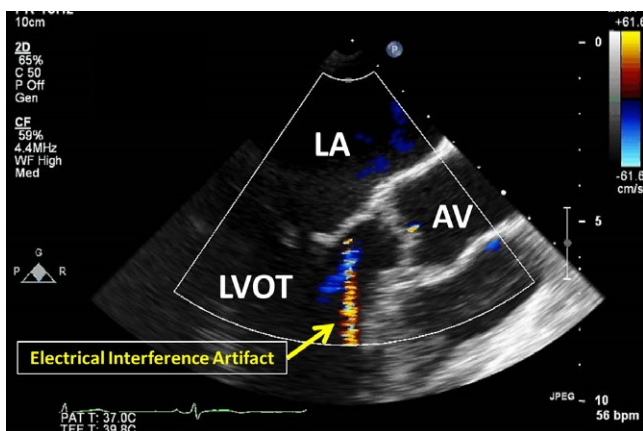
FIGURE 17 (Corresponds to Movie S13). Electrical interference artifact (yellow arrow) from unshielded electrical appliance or broken probe. AV = aortic valve; LA = left atrium; LVOT = left ventricular outflow tract

This artifact can be seen with a malfunctioning ultrasound probe, but it mainly occurs when other unshielded pieces of electrical equipment are turned on near the ultrasound machine. The external electronic signals are detected by the ultrasound system and these result in a band-like pattern over the normal ultrasound image.⁶⁰ This artifact is easily recognizable because it has a geometric shape and appears in all windows while the electrical equipment is still on or unshielded (Figure 17). Hence, there have not been any reported cases of this artifact leading to misdiagnoses.

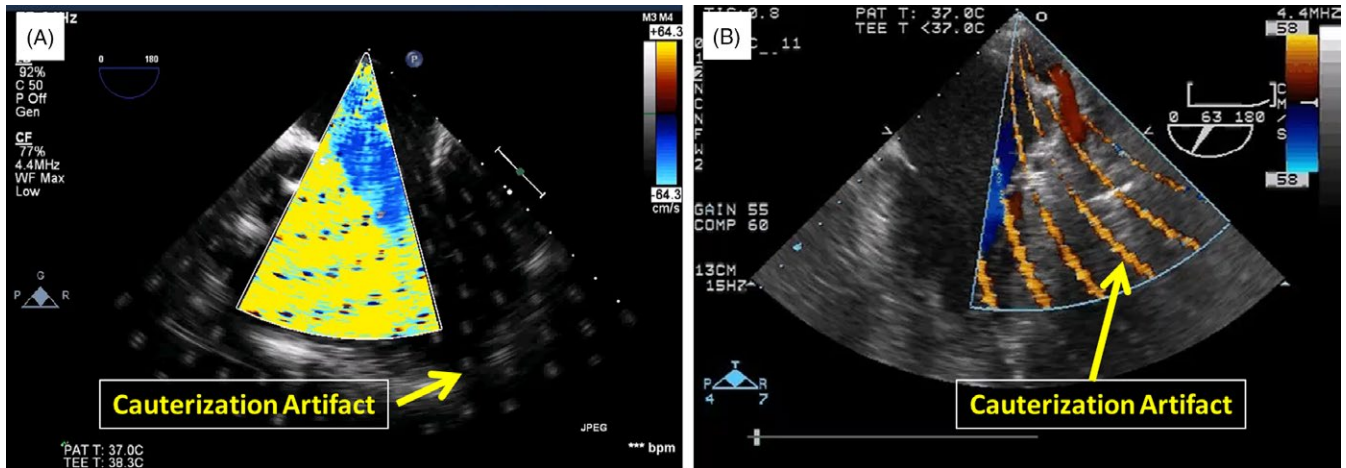
FIGURE 18 (Panel A corresponds to Movie S14, and Panel B corresponds to Movie S15). Fan-shaped cauterization artifacts due to interference from Bovie cauterizer seen on both grayscale (Panel A) and color Doppler imaging (Panel B)

Cauterization artifact is another example of how external electrical equipment can cause distorted ultrasound images. The artifact produced has a characteristic image of a geometric fan-shaped interference pattern, masking any resemblance of an anatomic structure in the displayed image (Figure 18).

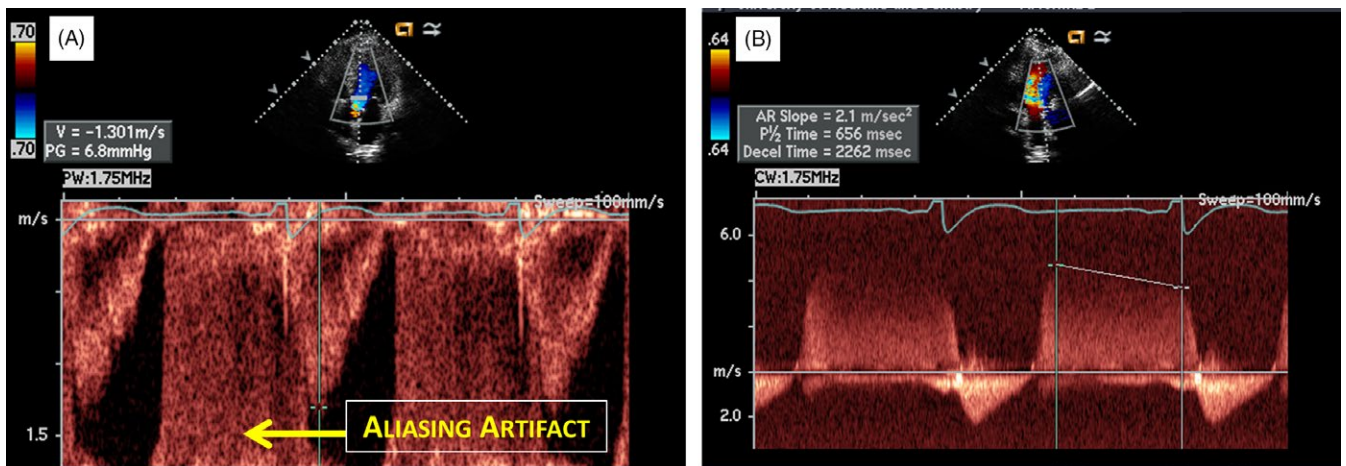
FIGURE 19 Panel A—Aliasing artifact (yellow arrow) of high-velocity aortic regurgitation jet on pulsed-wave Doppler. Panel B—Aliasing artifact eliminated with the use of continuous-wave Doppler

Aliasing artifacts are most commonly apparent in vessel and valvular stenosis. In these high flow states, the default PRF is usually set too low on spectral or color Doppler. Thus, the image shows flow reversal (Figure 19), which may confuse a clinician who is unaware of this artifact

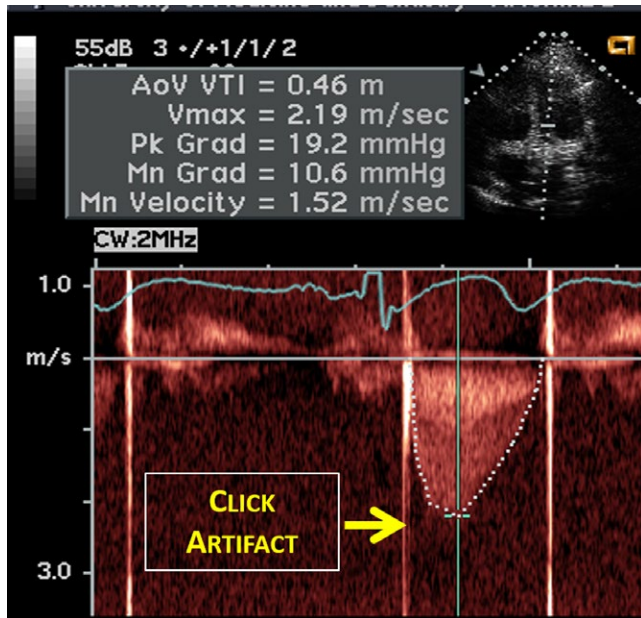
FIGURE 20 Click artifact (yellow arrow) resulting from opening and closing of mechanical aortic valve

two semicircular leaflets that pivot on a hinge. When the leaflets open, blood flows between one rectangular and two semicircular openings. When closed, some blood leaks back between the two leaflets and between the leaflets and the housing around the valve. Compared to a native heart valve, these mechanical valves demonstrate high turbulent shear stresses at high-velocity gradients immediately distal to the valve leaflets. Moreover, when the valve closes, a high-pressure difference develops and causes a fast-moving flow that leaks around the hinge of the valve.⁶⁷ On Doppler, the transducer detects these high velocities and produces a brief, spiked signal that is more intense than that seen on a normal Doppler scan (Figure 20).

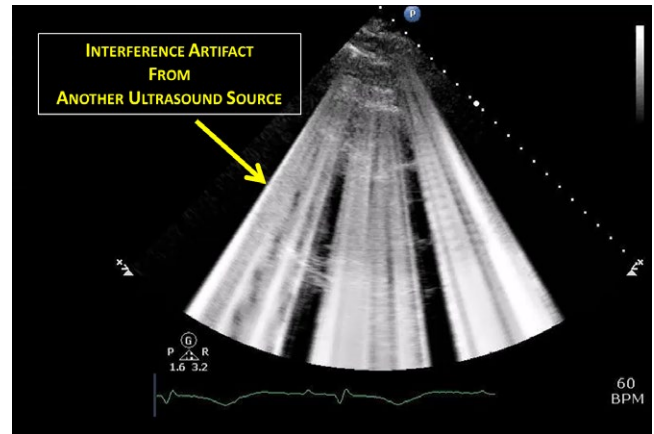
FIGURE 21 (Corresponds to Movie S16). Fan-shaped artifact seen on cardiac ultrasound from the interference of ultrasound waves from another ultrasound source, namely the intra-pulmonary EKOS thrombolysis system

This artifact can be seen with either a broken probe or with another ultrasound system in use, such as EKOS. The EKOS system is a form of catheter-based thrombolytic delivery system used to treat pulmonary emboli. It uses acoustic microstreaming and ultrasonic agitation via ultrasound energy from a series of ultrasound transducer elements to alter thrombus structure and allow the thrombolytic therapy to be more effective.⁶⁸ The interaction between the frequency from the ultrasound transducer and the pulsations of lower frequencies from the EKOS system ends up creating a sort of fan-shaped, “windshield wiper” artifact (Figure 21).

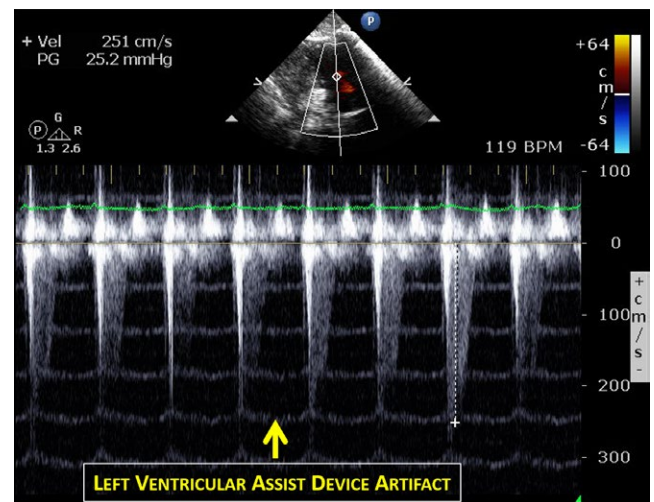
FIGURE 22 Regularly spaced wavy horizontal artifact (yellow arrow) from Impella left ventricular assist device superimposed on continuous-wave Doppler tracing of tricuspid regurgitation
